Geotechnical Report

11 Centre Road Subdivision
Ocean Grove, Dunedin

Willowridge Developments
Limited

April 2022

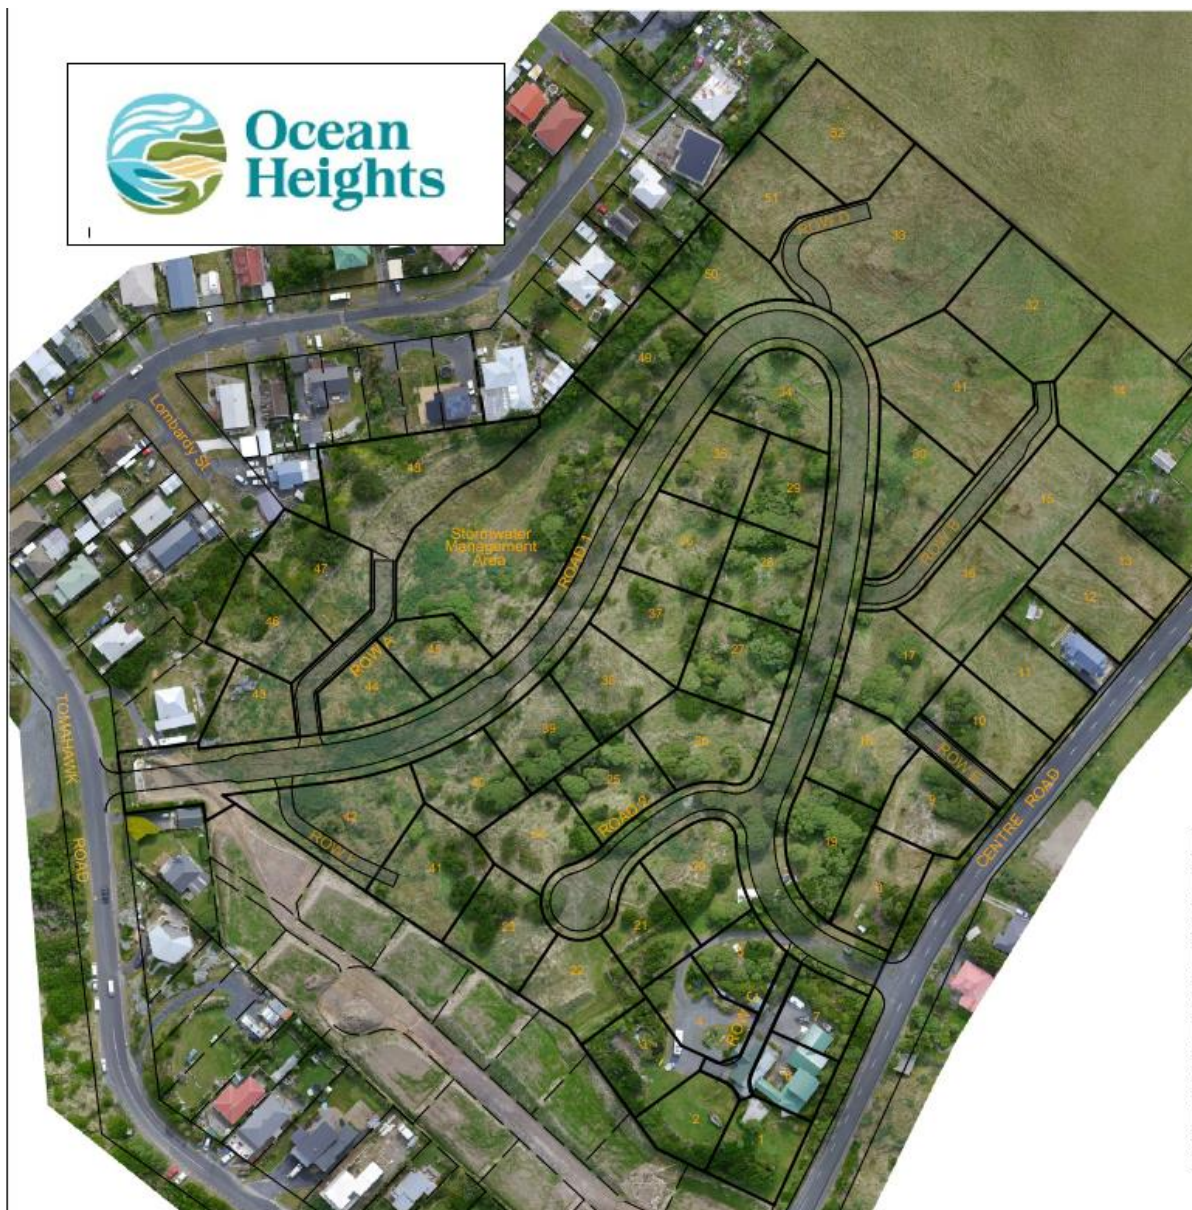
Photo 1.1 – Proposed subdivision scheme plan, 11 Centre Road.

The proposed subdivision layout is shown in Figure 1, Appendix A. Main access will be off Tomahawk Road and Centre Road.

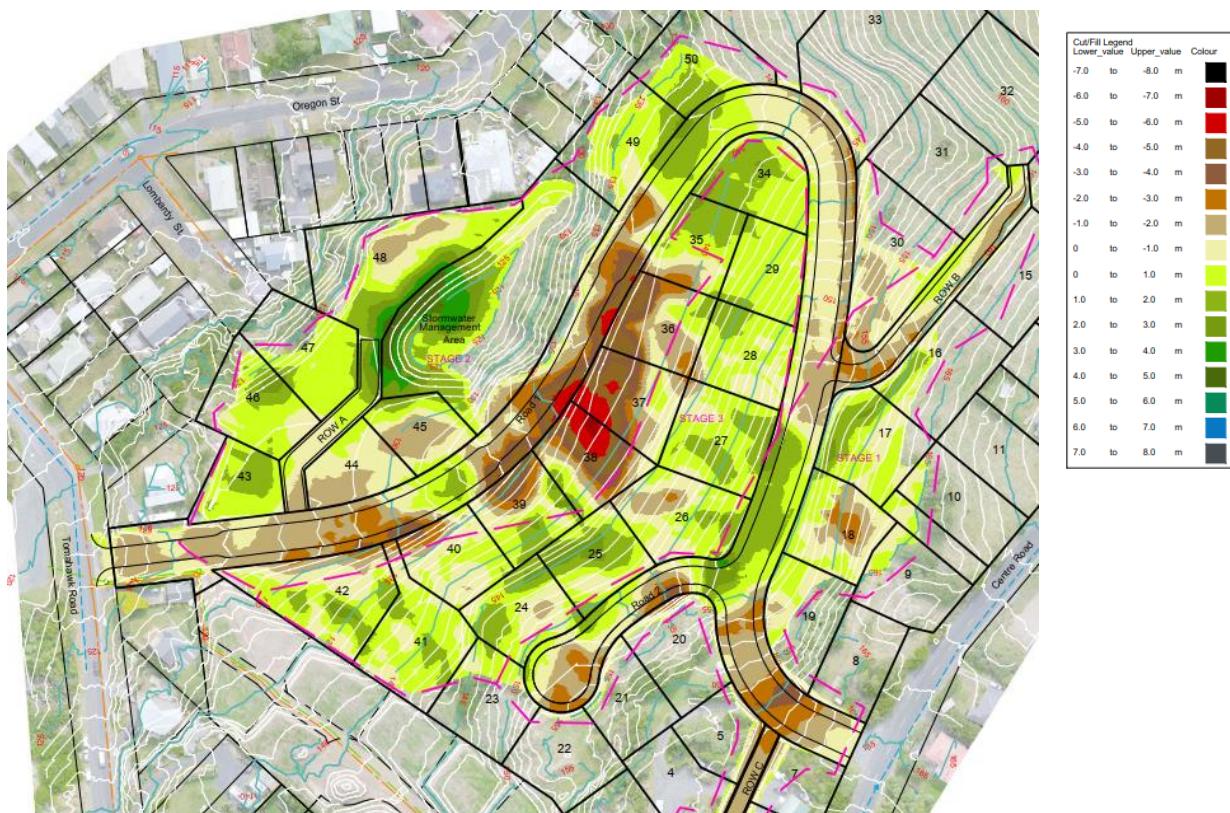
Relatively significant earthworks are proposed as shown in Figure 2.1, with localised cuts of up to 6 m and fills of up to 4 m. The largest cuts are localised to areas where sand dunes are to be levelled. No earthworks are proposed on the sloping north-eastern lots, which naturally slope at up to 20 degrees.

Figure 2.1: Preliminary Earthworks Plans (Reference Paterson Pitts, D17023-02, Dated August 2021)

All final lot profiles appear to generally slope less than 20 degrees and often much gentler. Some localised areas of modified land, associated with road cuts slope up to 30 degrees locally but in isolated areas only.

As noted in Figure 2.1, some filling of lots is required to meet final design levels.

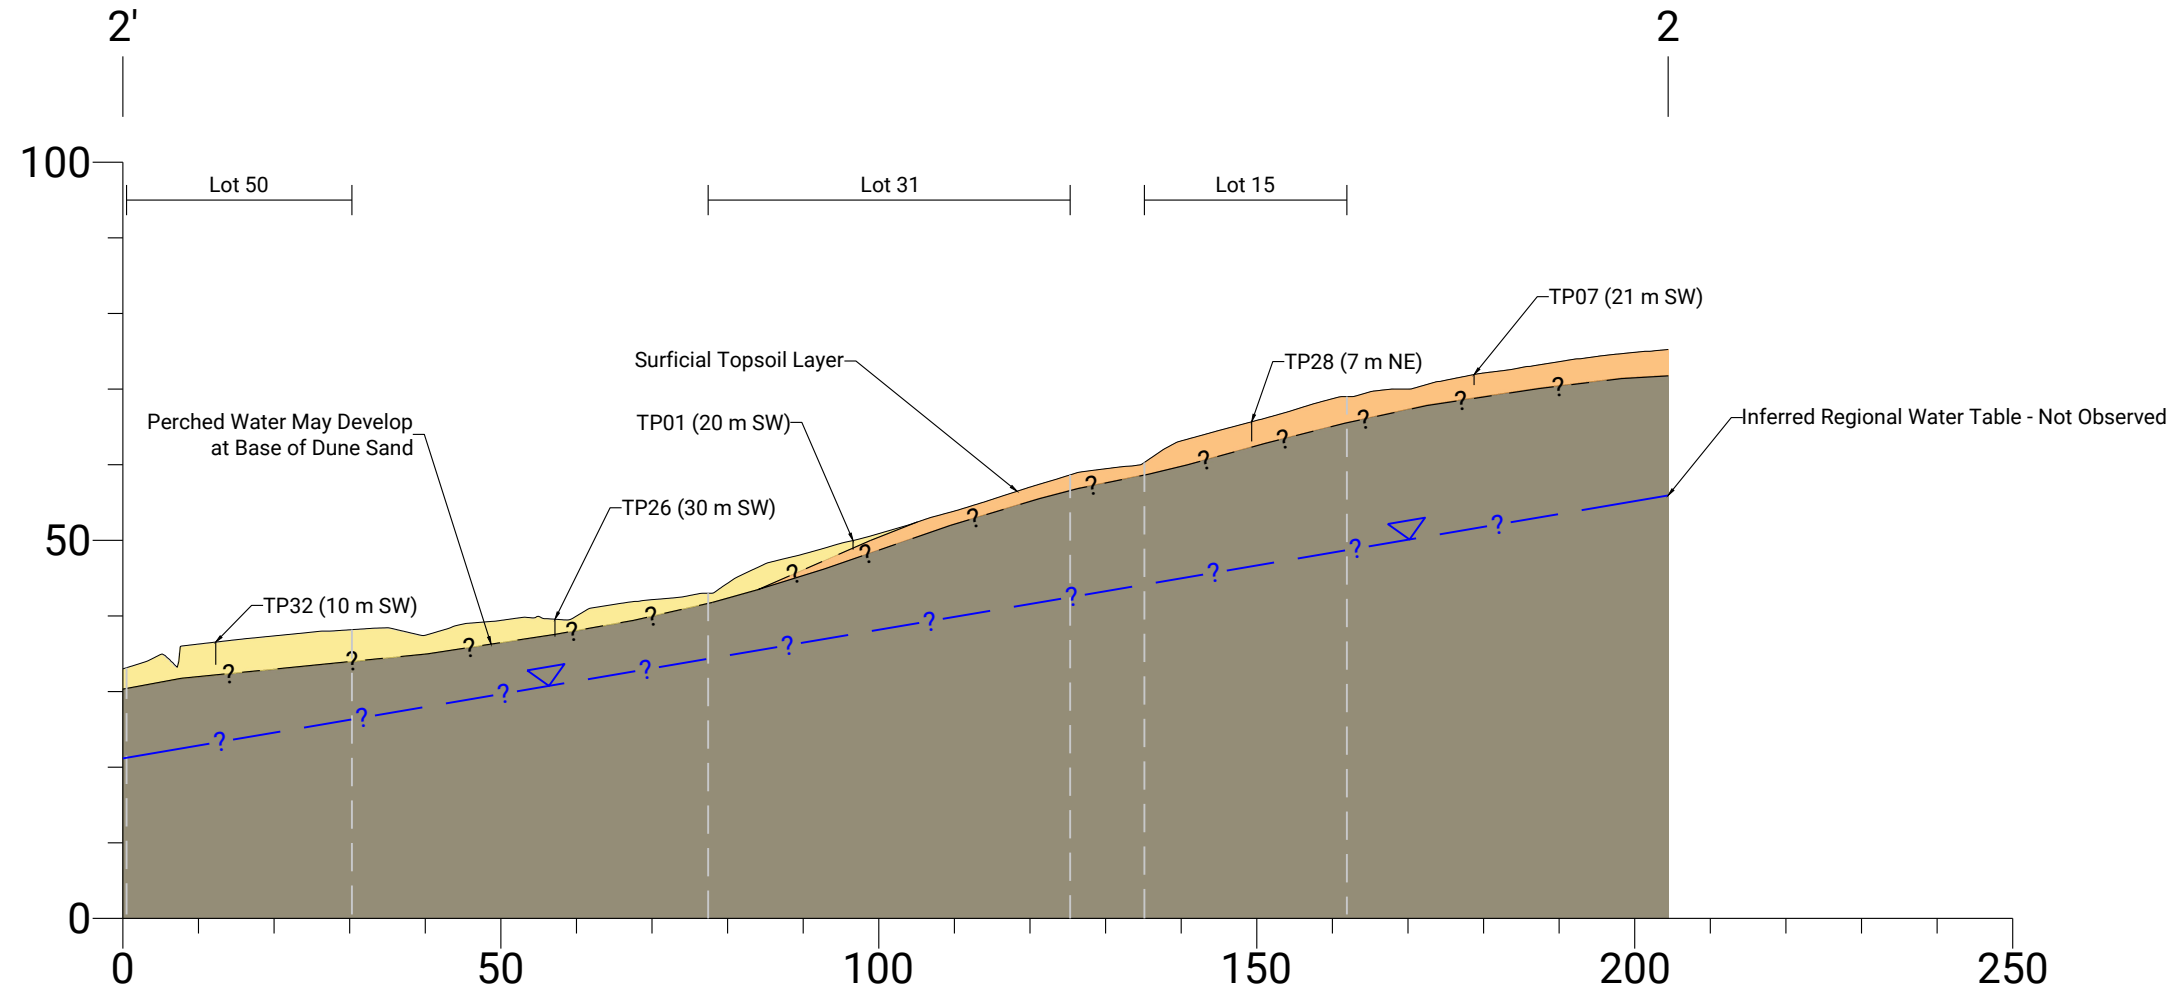
- Dune Sand
- Colluvium
- Basaltic Bedrock (Minor Near-Surface Weathering)

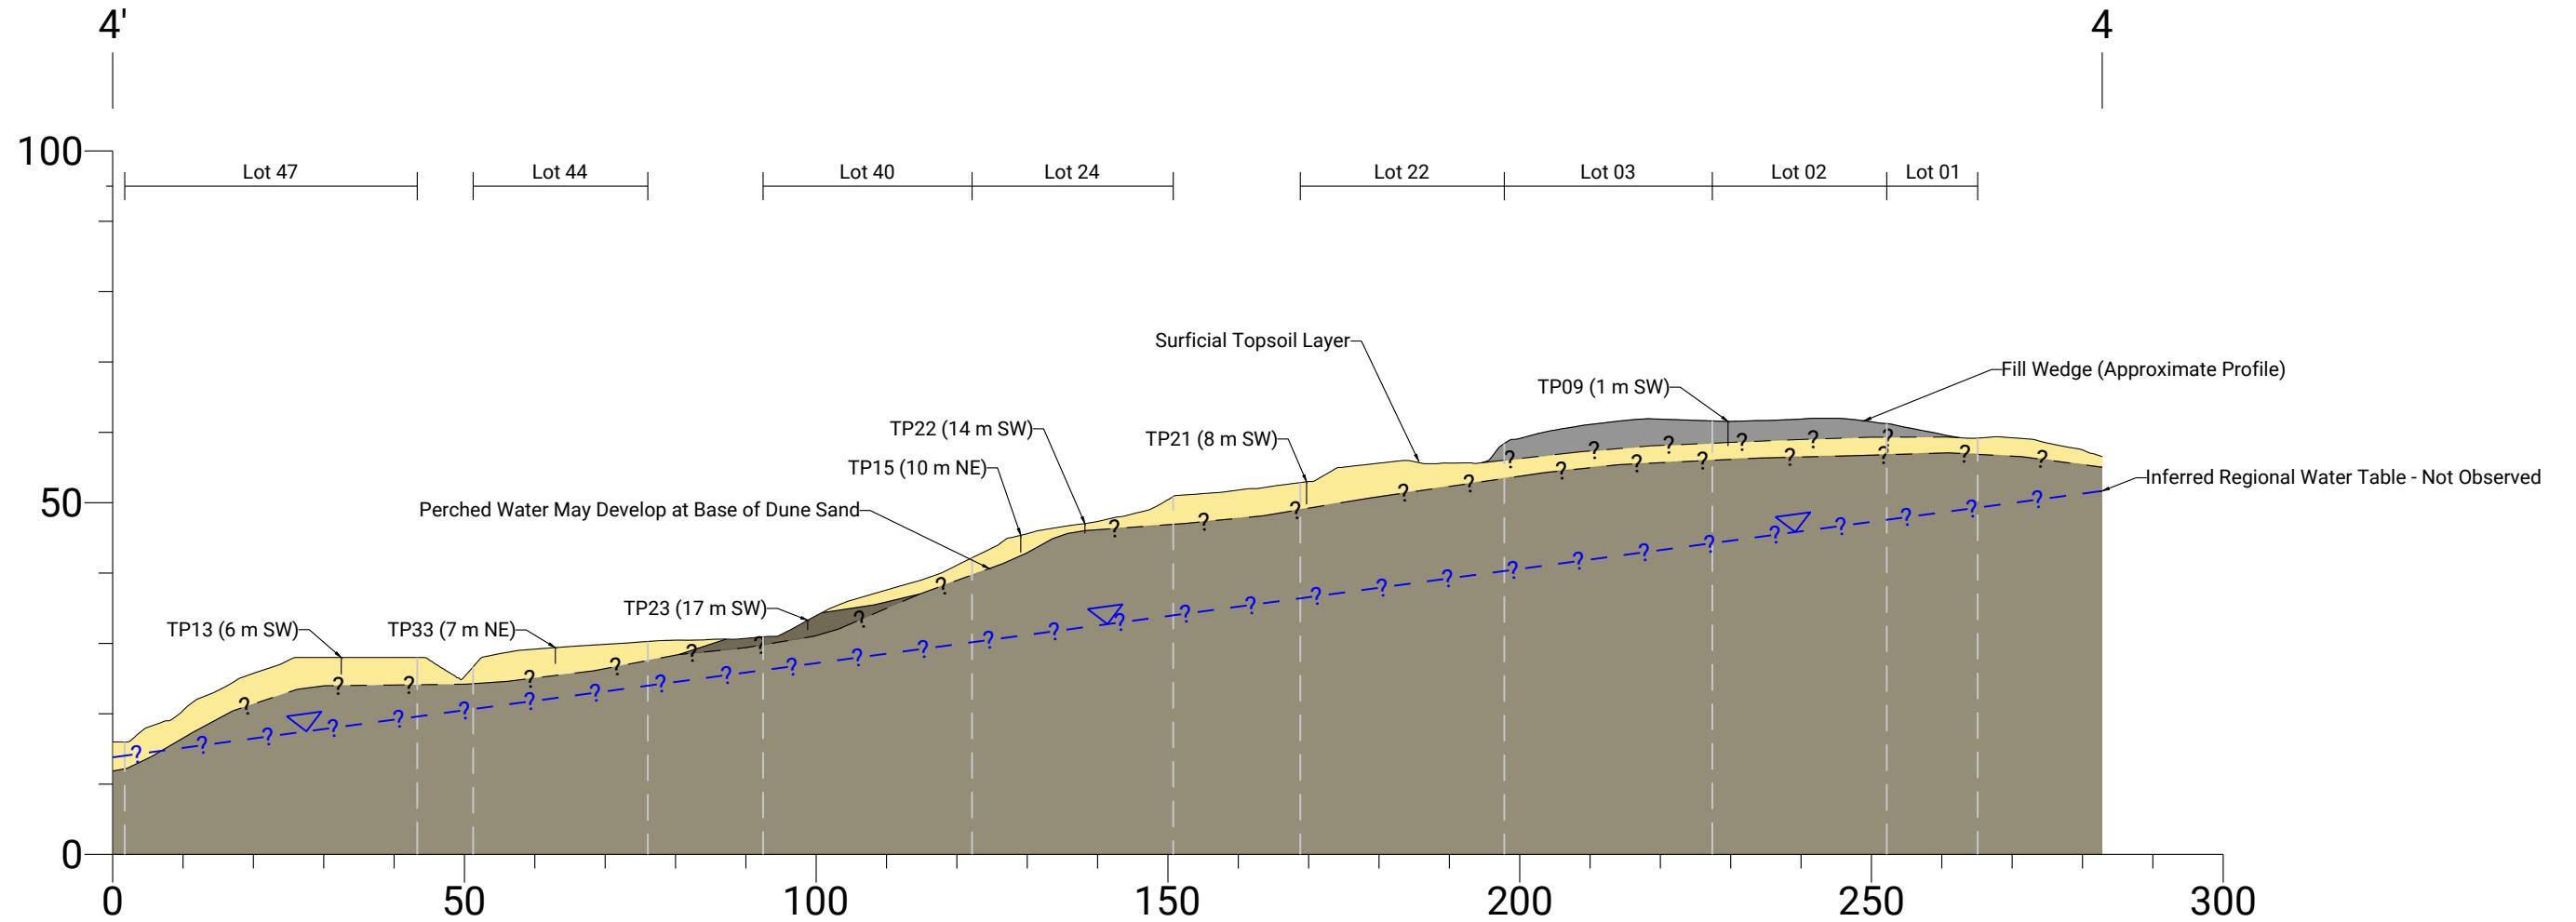
- Fill
- Dune Sand
- Completely Weathered Volcanics
- Basaltic Bedrock (Minor Near-Surface Weathering)

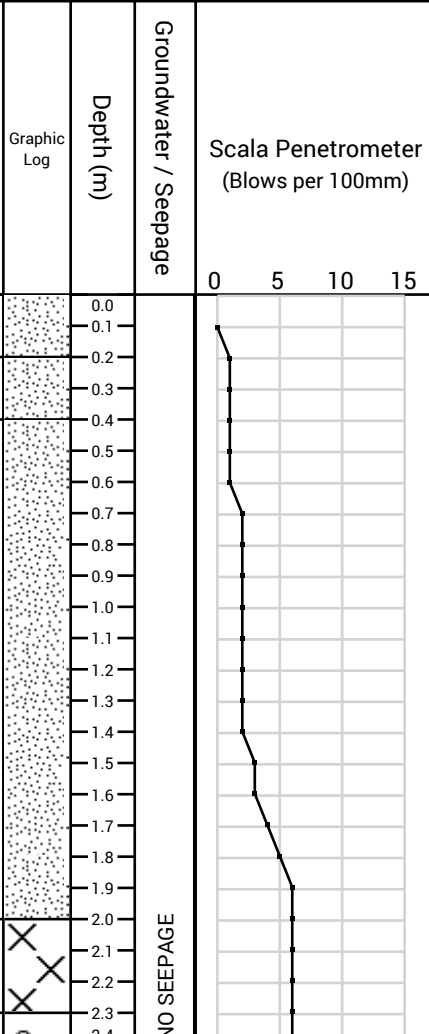
Total Excavation Depth = 2.3 m

Soil / Rock Type	Description	Graphic Log	Depth (m)	Groundwater / Seepage	Scala Penetrometer (Blows per 100mm)
TOPSOIL	Fine to medium SAND with some organics and silt; brown. Loose; moist; gap graded.		0m		
BURIED TOPSOIL	Fine to medium SAND with trace silt and organics; brown. Medium dense; moist; gap graded.		0.2m		
DUNE SAND	Fine to medium SAND with rare silt; light brown. Medium dense; moist; gap graded.		0.4m		
COMPLETELY WEATHERED VOLCANICS	SILT with a trace of sand, clay and gravel; grey / orange / brown. Very stiff; moist; non plastic; sand, fine to coarse; gravel, fine to coarse subrounded to subangular, weathered volcanics.		2m		
-	-		2.3m		
-	-		2.4m
